Excavation and Watching Brief Report

Kirkmichael, Balblair, Black Isle Excavation and Watching Brief Report Vs2

Report No.	KML16-1
Site Code	KML16
Client	Kirkmichael Trust
Planning Ref	n/a
OS Grid Ref	NH 70590 65855
Date/ revision	28/11/2017
Author	Lynne McKeggie

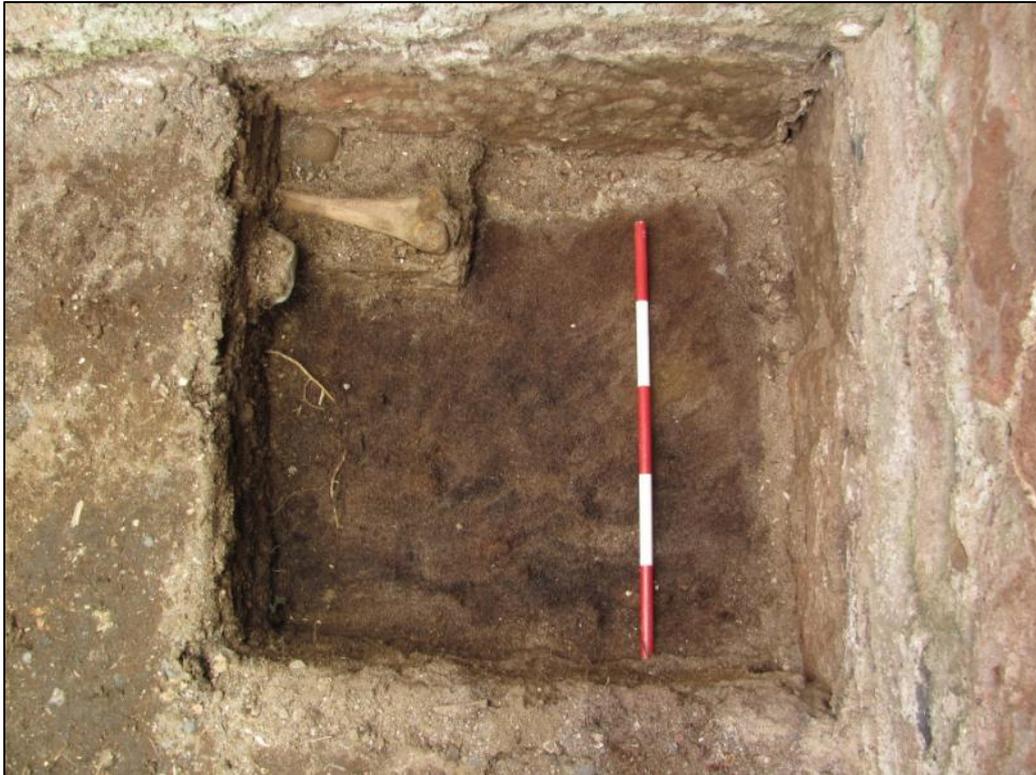
Plate 1: Organic floor layer in Test Pit 1 (2013) (50cm scale)

around 0.15m below the modern surface (see plate 1). This was the only floor layer uncovered and it was not found in Test Pit 2. This suggests that this floor layer has been disturbed in at least the north east end of the Nave.

Test Pit 1 also revealed foundations approximately 0.45m below the modern surface. The foundation consisted of large roughly dressed and undressed stones which underlay the existing wall and extended 0.3m into the building. These features were not revealed in Test Pit 2, but it is possible that the equivalent depth was not reached due to in-situ remains of what appeared to be a small coffin, which were not disturbed during the test-pitting programme.

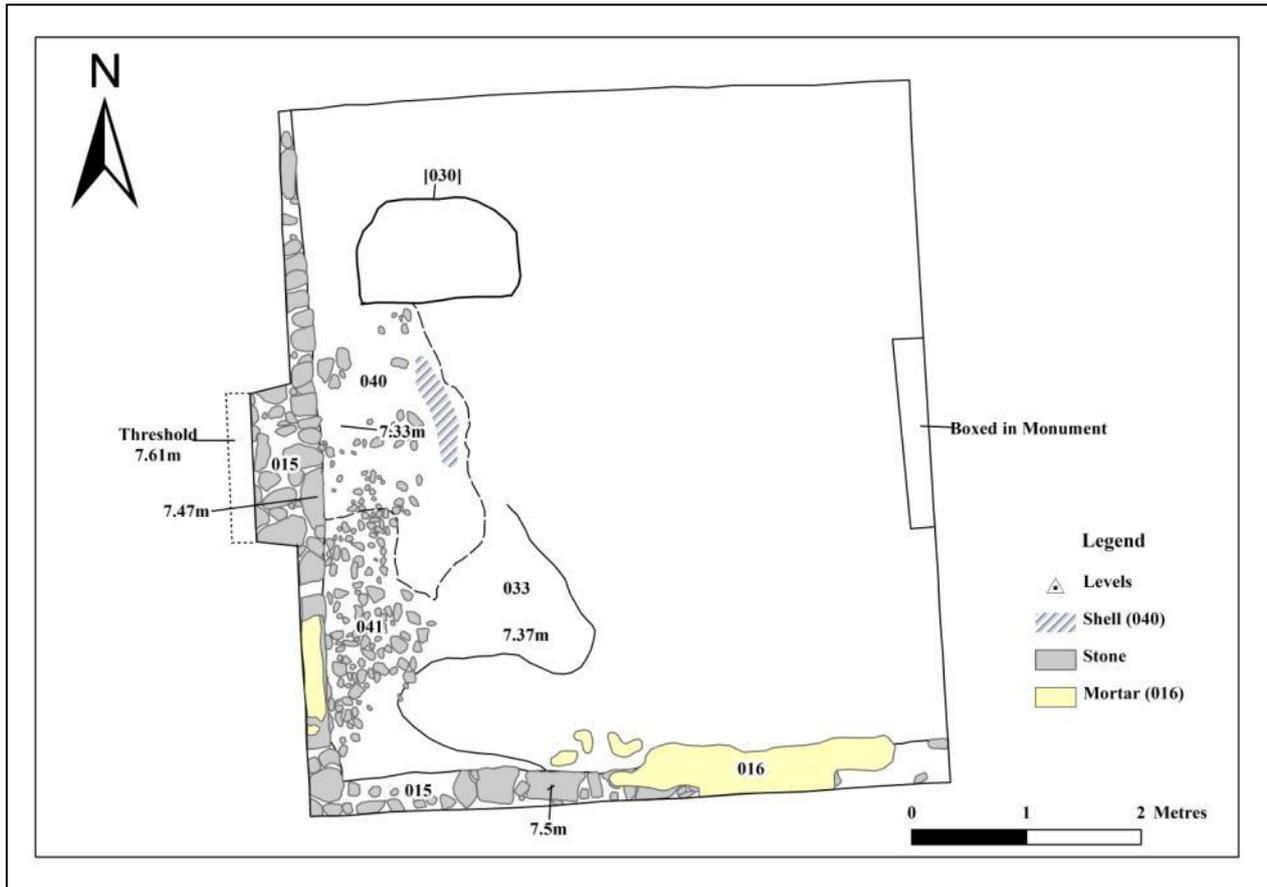
Figure 3: Trench 1 with phases 1 and 2b

This phase appeared to relate to a construction or renovation event and was represented by layers of material around the entrance. No dating evidence was recovered but it is likely that this relates to the current building walls. Layers **033**, **040** and **041** consisted of dark organic soil layers and a spread of stones concentrated around an area just to the south of the entrance and in its vicinity. These layers appeared to represent trampling of soil in the process of working on the building and a dump of stones, possibly to infill an area which became boggy. Context 040 was cut by **030**, which belongs to phase 4.

Overlying these was **029**, a sandy reddish-pink deposit, which was compacted and scattered with pieces of plaster. Plaster **016** was also found immediately on top of wall **015** along both the southern and eastern parts.

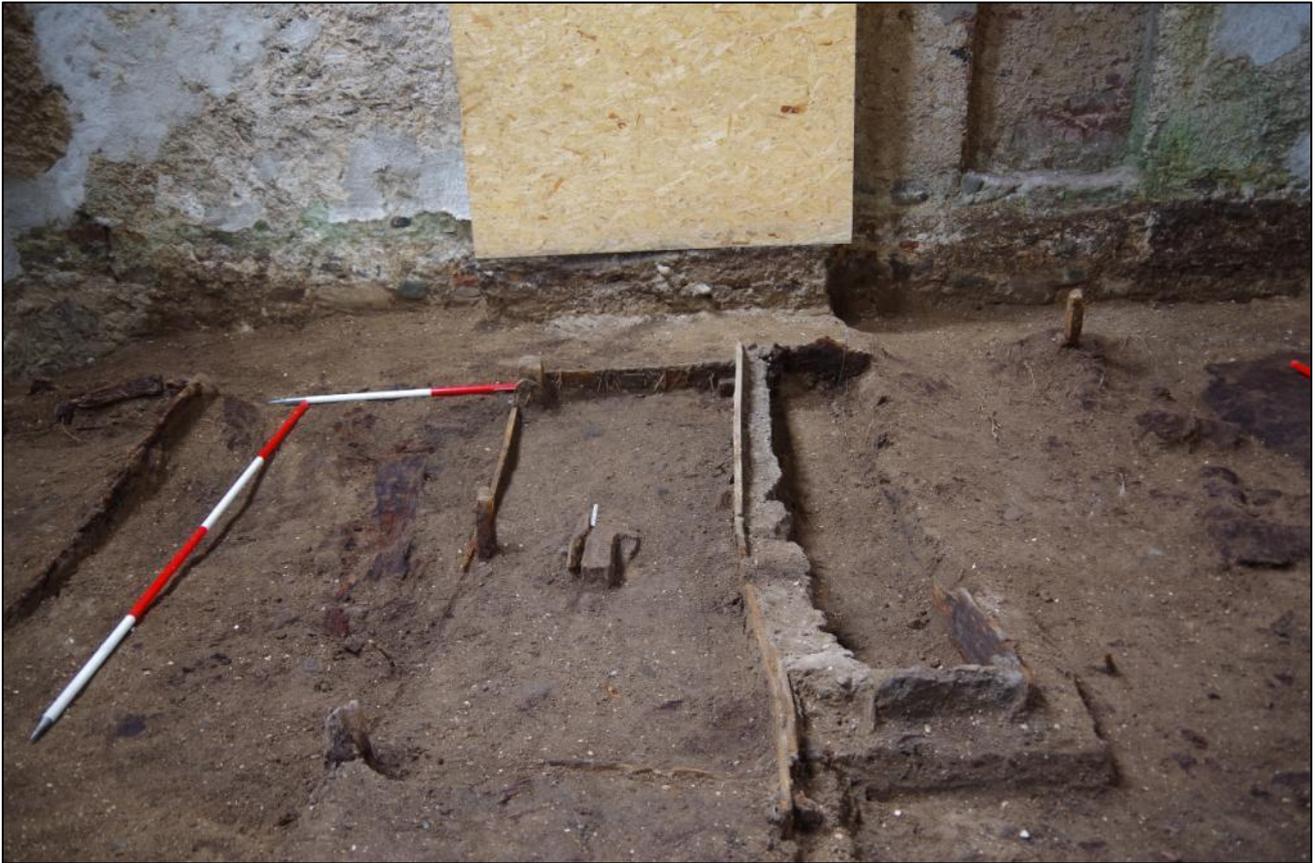
Plate 2: Wooden structures from phase 3 (2m & 1m scales)

Structure **020** was in the centre of the trench and had two modern white ceramic vases placed within the centre of the structure and a setting of stones and was around 2.3m long by 0.85m wide. The wooden boards were found to have plant roots tacked on to them with U-shaped tacks (see Plate 3).

Structure **023** was located in the north of the trench and was around 1.8m long. The width of the structure was unclear as the wooden boards only extended 0.5m, but a board against the north wall (if it belonged to this structure) would have made it 1.2m wide. It had stones propping up the boards at its southern corners.

Structure **024** was 2m long but just 0.4m wide. The structure contained a mound of dark earth sterile of finds, shell or human bone reminiscent of gardening compost (layer **019**).

The material within these structures were given separate contexts but, with the exception of **019**, were found to be part of phase 4. All wooden structures were removed in order to achieve the required ground level.

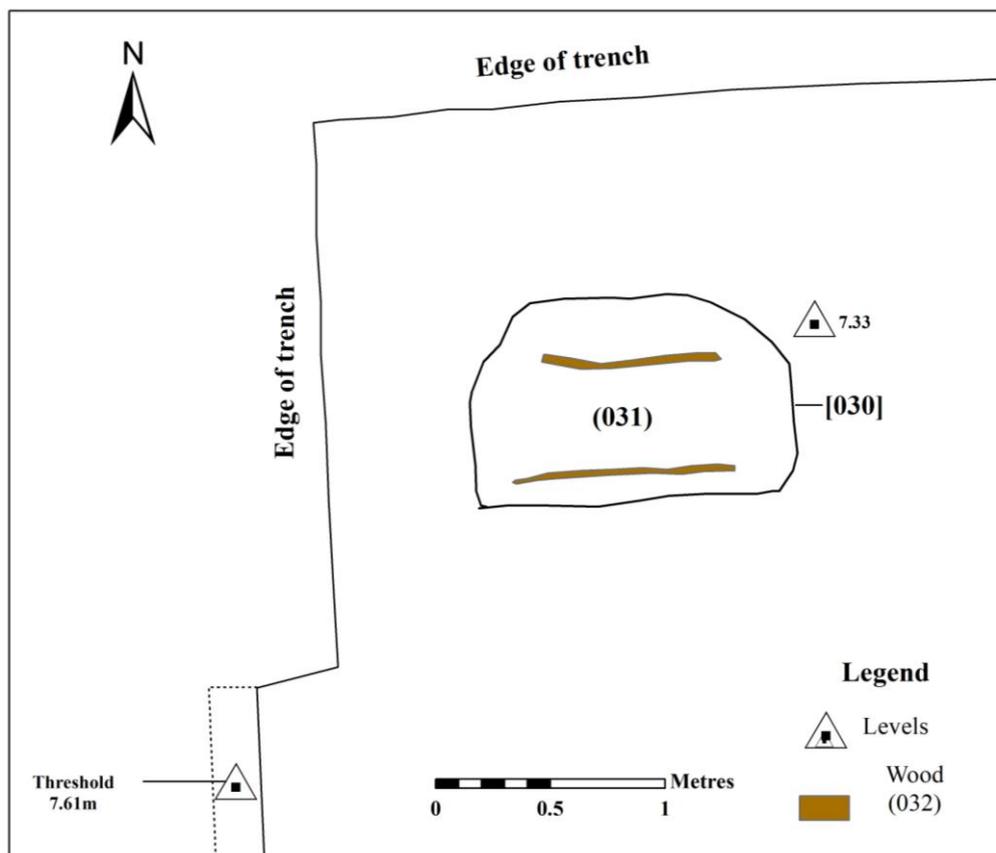
Figure 4: Cut [030] with wooden object

One of the earliest actions that we have evidence for in this phase was a sub-rectangular cut **[030]** 1.4m by 0.9m which contains a homogenous dark brown-grey loam which was notably soft (**031**). This surrounded two straight wooden planks **032** that were parallel to each other and were aligned along the feature (see Figure 4). This feature cut **040** and so post-dates the construction phase, but was underneath around 0.4m of **005** deposits. This was interpreted as a possible grave cut due to the size of the feature and the fact that it appeared to contain a wooden structure of some kind. However, only the top 20mm of the feature was excavated as this reached our excavation limit, so the character and depth of the feature was not established and nor was the nature of its contents. This feature and the revealed wooden object was preserved in situ.

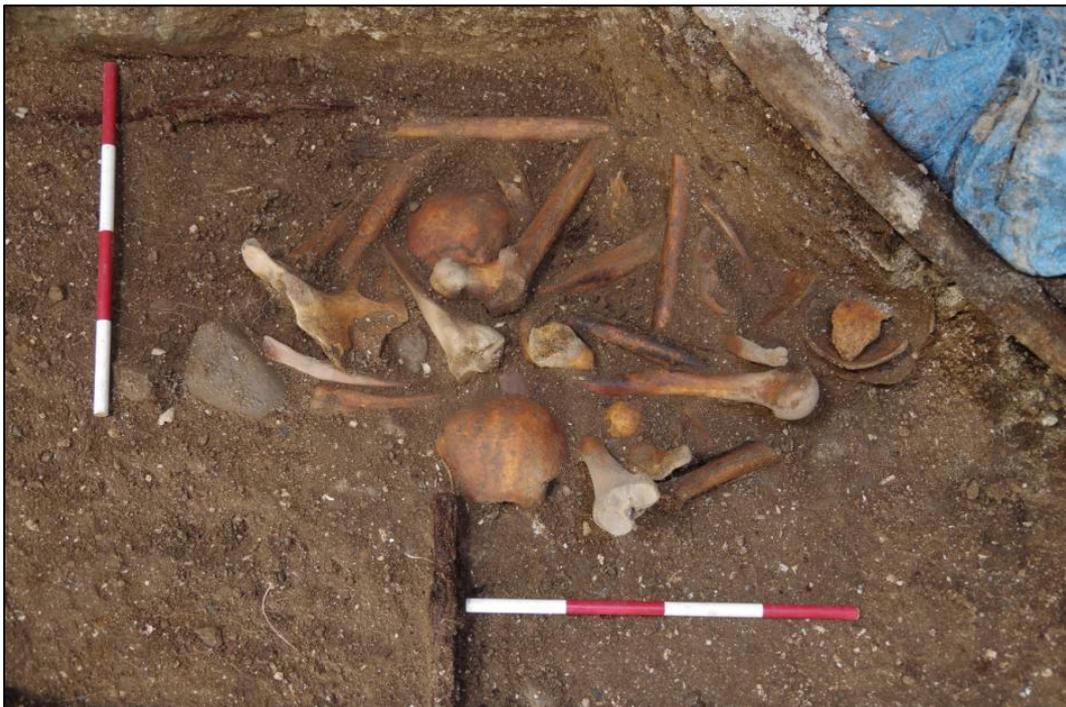
Plate 4: Bone cache (context 021) (40cm scales)

Six caches of human bone were deposited within Trench 1, mostly near the edges of the room to the north and east (see Figure 5). The caches occur at various levels, suggesting that they were deposited at different times as the soil steadily built up within the kirk. These concentrated areas of bone contained an average of 3-4 bags of bones each. The caches represented the largest and most obvious bones from the human body including long bones and skull fragments, suggesting that these were selected following disturbance and that smaller less prominent bones may have been missed. None of the caches represent the remains of a single individual. In some instances the remains had been carefully grouped and stacked, in others they were more jumbled (see Plate 4). The act of placing each cache of human remains was recorded as an individual context (**013, 014, 021, 025, 038**) except in one instance where the remains were deposited within a cut [**007**]. This cut contained a dark lower fill (**012**) which included the human remains, and a homogenous upper fill sterile of finds or inclusions (**008**) which appears to be clean topsoil that was used to infill the cut. There were no artefacts directly associated with the bone caches.

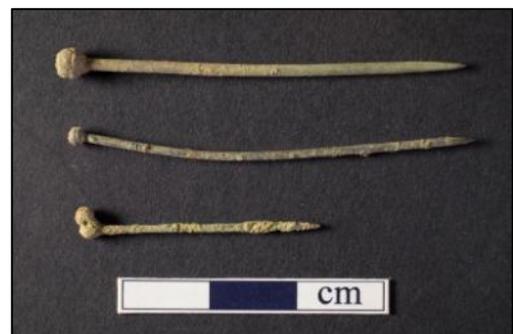
Plate 5: Shroud pins

The artefacts that have been recovered from this phase include the most interesting finds and almost all of the Small Finds are from the 'grave deposit' layers. Most relevant to this interpretation is the coffin furniture (including coffin handles, nails, and copper alloy tacks) and shroud pins, of which there are many examples (SFs 3, 6, 7, 11, 13, 14, 17, 22 and 28).

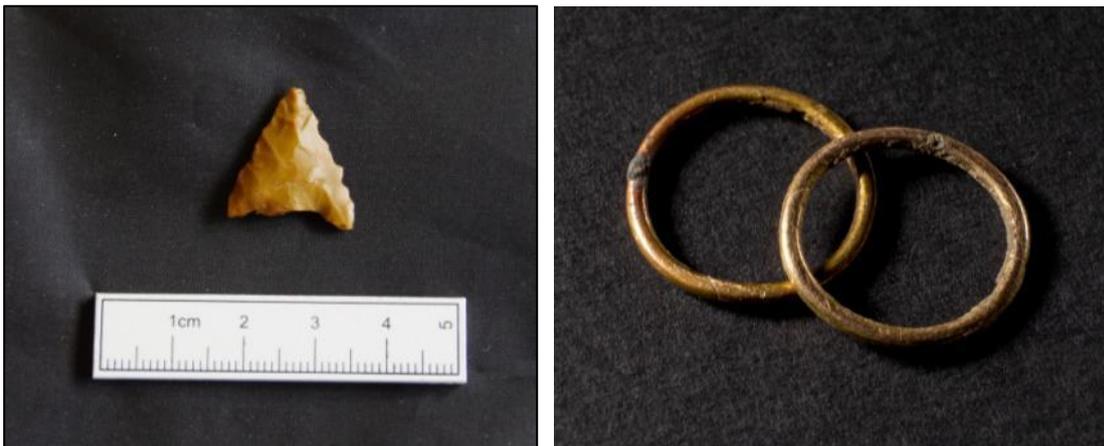
Plate 6: Flint arrowhead (SF4) and 'gold earrings' (SF9)

Two yellow metal rings that appear to be earrings were also recovered separately, but in the same area of the trench (SF9). The lack of corrosion and colour of the metal suggests that these are low-quality gold, but X-ray

fluorescence has not been undertaken to confirm this. There are some manufacturing seams and a tiny corroded copper-alloy pin in each ring which may be a hinge to allow fitting.⁵ The rings are incredibly similar in form, although their size does vary slightly with one being of marginally greater diameter than the other. However the overall similarity of the rings suggests that they form a pair, and this reinforces the interpretation of them as earrings. (See Plate 6)

An unexpected find was a flint arrowhead, honey coloured with barbs and tang, although the tang has broken (SF4, see Plate 6). It was found within **005** and is likely to have come in with excess material from grave-digging. It is possible that this artefact has been imported from almost anywhere as a personal item which has become lost, potentially even buried as a talisman. It is also possible that prehistoric remains have been disturbed in the kirkyard whilst digging graves. Two fragments of flint debitage were also found in this trench, but in deposits belonging to different phases (SF 32 and 33).

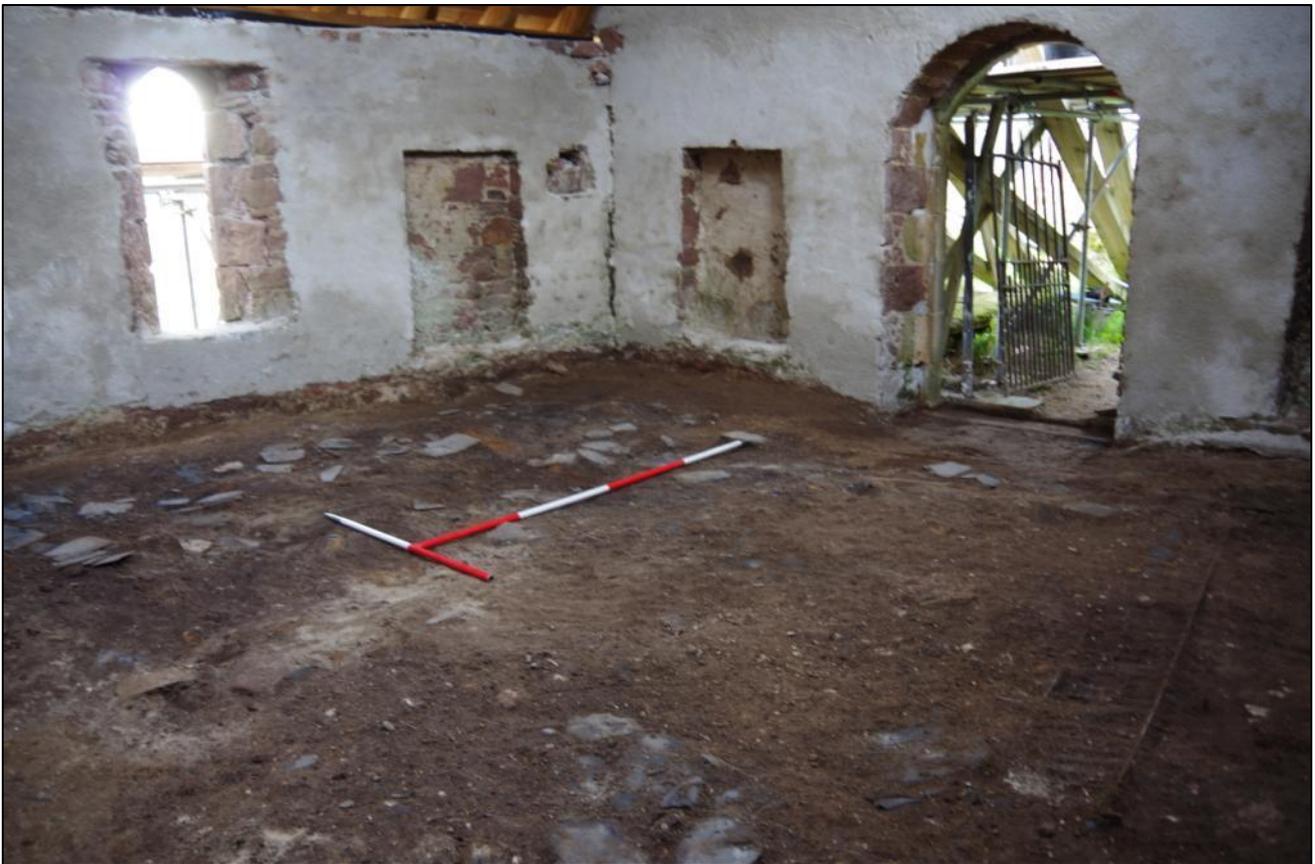
Plate 7: Modern material from phase 5 (2m & 1m scales)

The uppermost and most recent deposit of Trench 1 was **002**, consisting of lime mortar, rubble, fallen slates and wood from the roof, as well as modern rubbish from renovation works. This was removed and bagged for disposal. Occasional human remains were recovered – these were pieces that had been disturbed and were apparent on the surface, having been deposited within the kirk by visitors or locals upon discovery elsewhere on the site.⁸

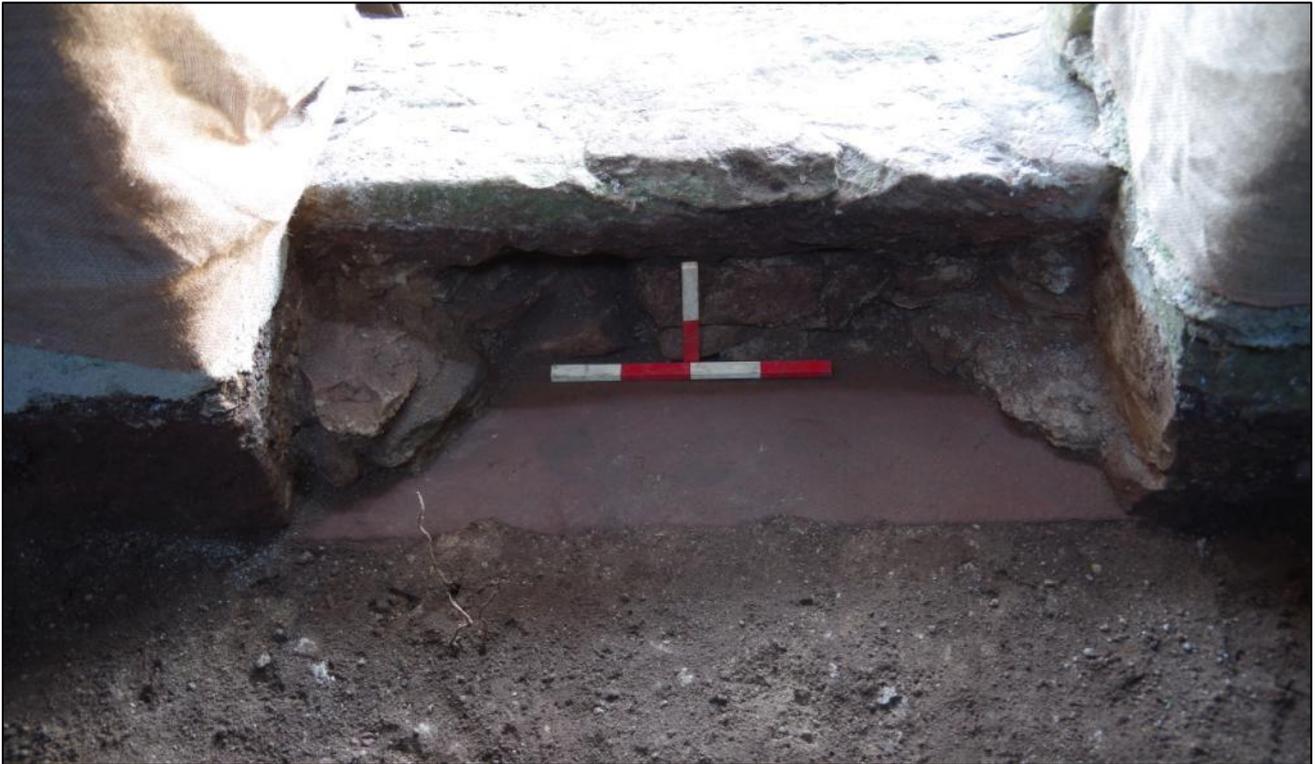
Plate 8: Lower threshold in Trench 2 (40cm & 20cm Scales)

An earlier threshold was uncovered at the limits of the excavation (0.3m below the current threshold). This was a sandstone slab with little sign of erosion or wear set into the lower wall that is likely to relate to an earlier phase of doorway (see Plate 8). This was covered by geotextile and preserved in situ beneath the present floor.

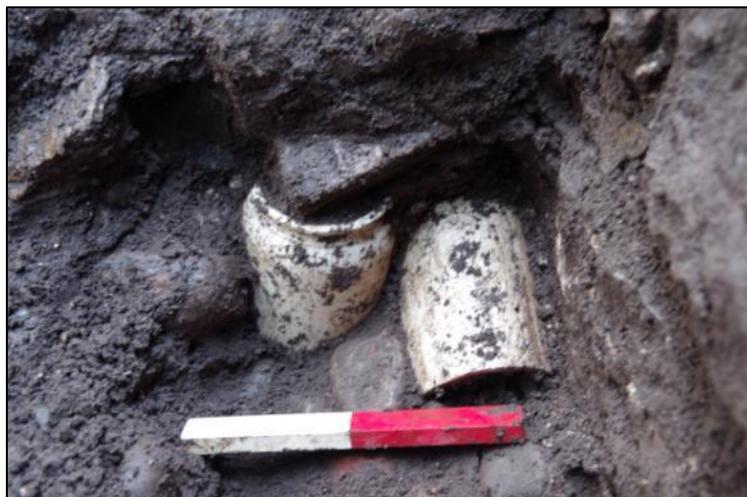
Plate 9: Earthenware from layer 44 (20cm scale)

Finds consisted of 3 earthenware jars, one fragmentary and 2 complete with slight damage (see Plate 9). These were found amongst the stones forming context 044. They appear to have been cleared from the graveyard and placed against the kirkyard wall (see Plate 9).

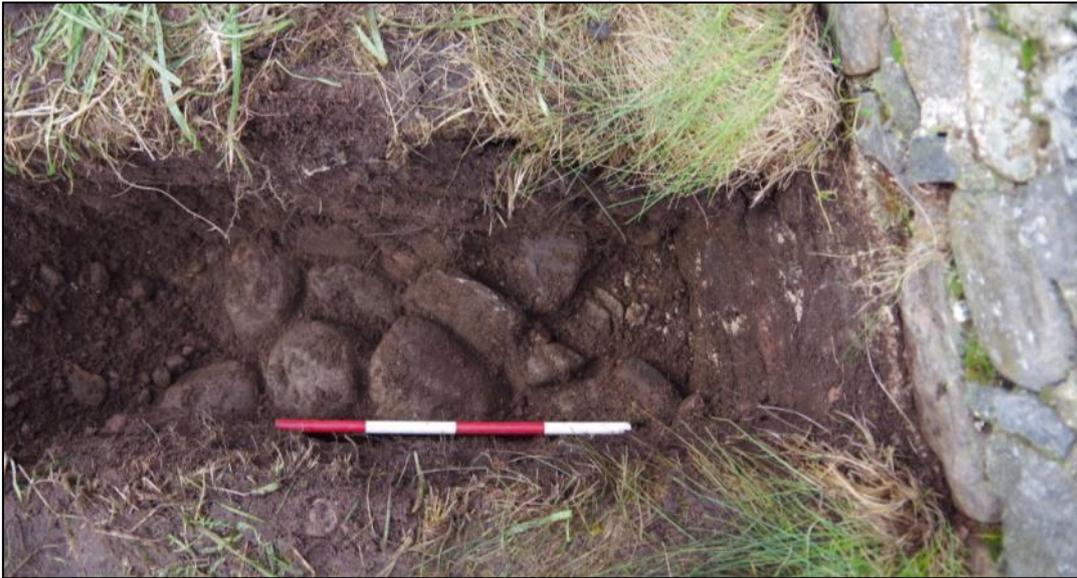
Plate 10: tumble of stones 048 on inside of kirkyard wall (40cm scale)

048 = tumble of medium and large stones (100-200mm) immediately against kirkyard wall and extending around 0.6m, 0.4m below surface level. Very loose with voids between stones. This probably relates to 043 above, representing rubble from the wall which has collapsed but not been re-incorporated into the structure (see Plate 10).

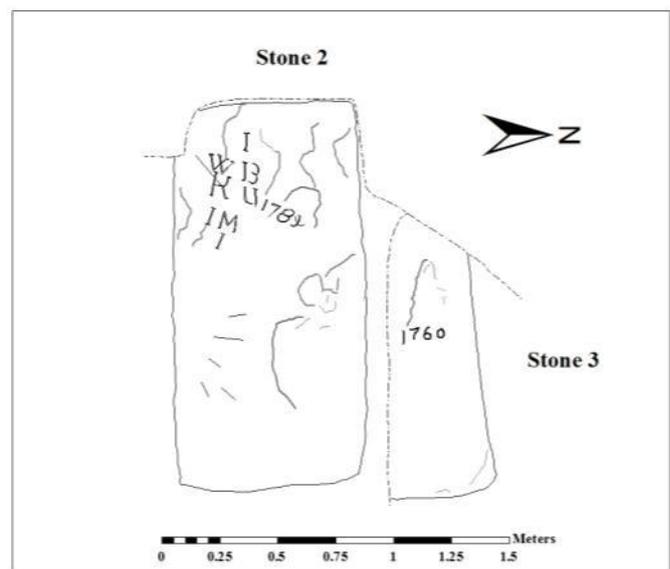
Figure 7: Stones 2 and 3

Stone 3 = This is also lying at an angle so that it dives underneath Stone 2. The only visible inscription is the date '1760'. 1.2m of the length of the stone and 0.4m of the width was revealed, the rest underlying stone 2 to the south and the turf to the west.

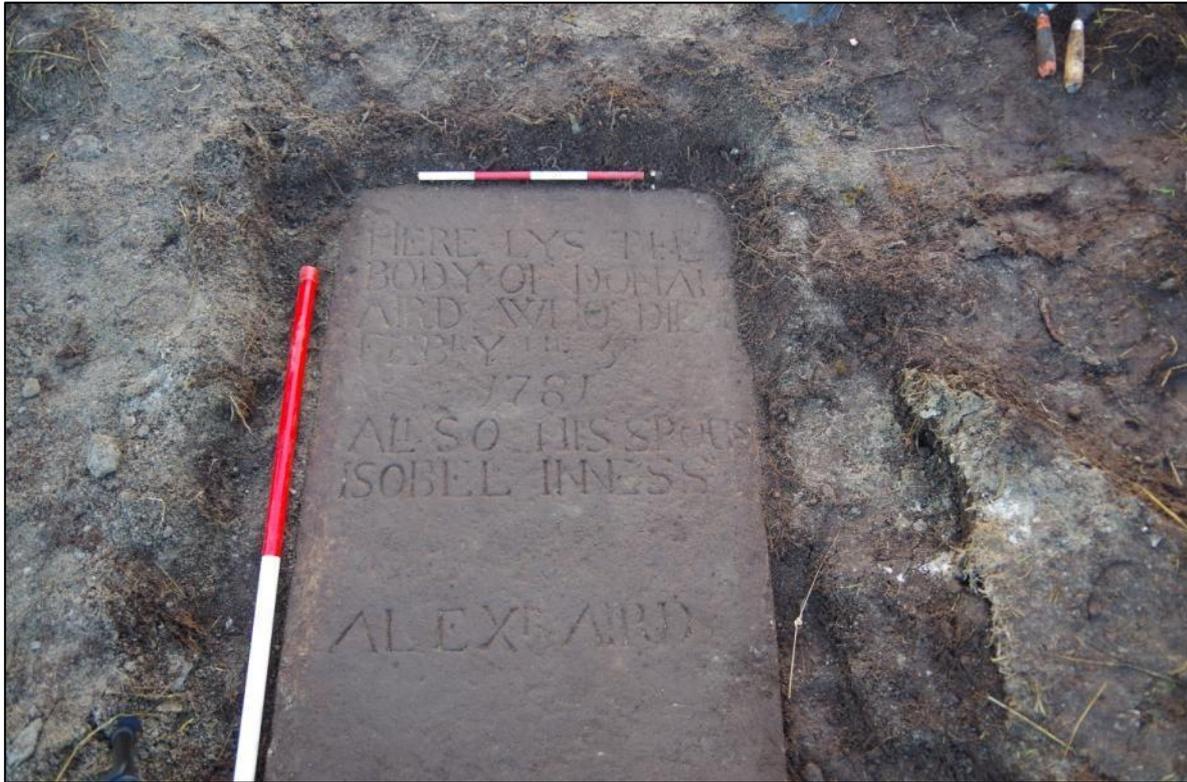
Plate 11: Stone 5 (1m & 40cm scales)

Stone 5 = To the east of the Kirkmichael Cross approximately 4-5m away lies this stone, inscribed with text dedicated to 3 individuals. The inscription reads “Here lys the body of Donal Aird who die[d] [F]ebry the 5th 1781, Allso his spouse Isobel Inness, Alexr Aird”. There is a chamfered border around the edge of this stone and the letters occasionally encroach upon it. The stone is 1.7m long and 0.7m wide.

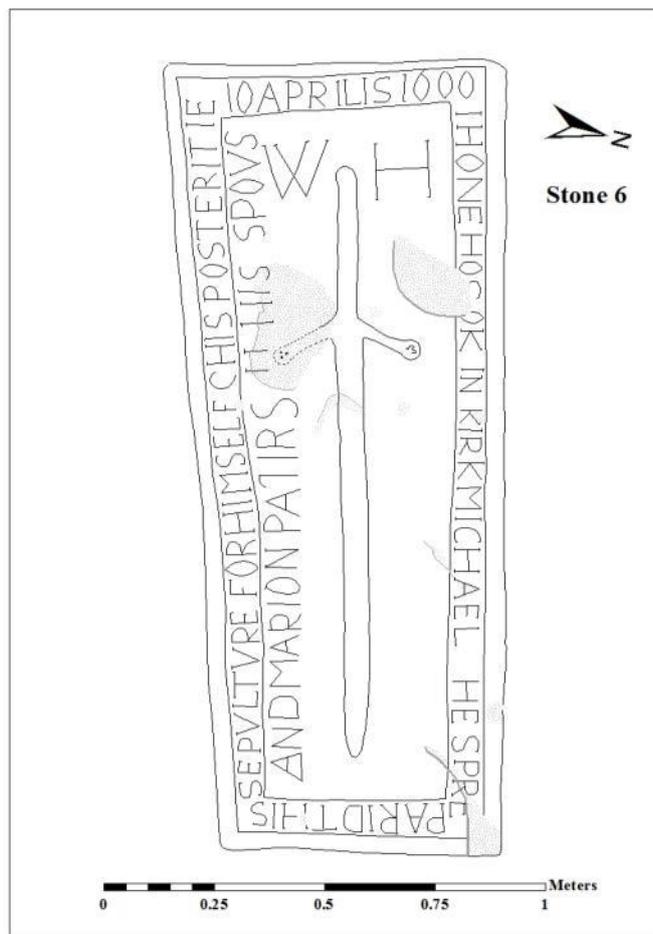
Figure 9: Stone 6 - sword stone with inscription

Stone 6 = To the north of Stone 5 lies this magnificent stone inscribed with a claymore type sword and with a surrounding inscription reading “10 Aprilis 1600 Ihone Hosok in Kirkmichael hes preparid this sepulture for himself & his posteritie, and Marion Patirson his spous”. It also bears the initials ‘W. H.’. This stone was seen by John Borland of Historic Environment Scotland who confirmed that the early 17th century date was consistent with the sword inscription, although this is an example of a pre-reformation fashion which was retained for some time in the local area. The spouse inscription seems to have been added later and the initials may also be a later addition. The stone is 1.83m long and has a maximum width of 0.77m at the eastern end tapering to 0.65m at the western end. (Figure 9)

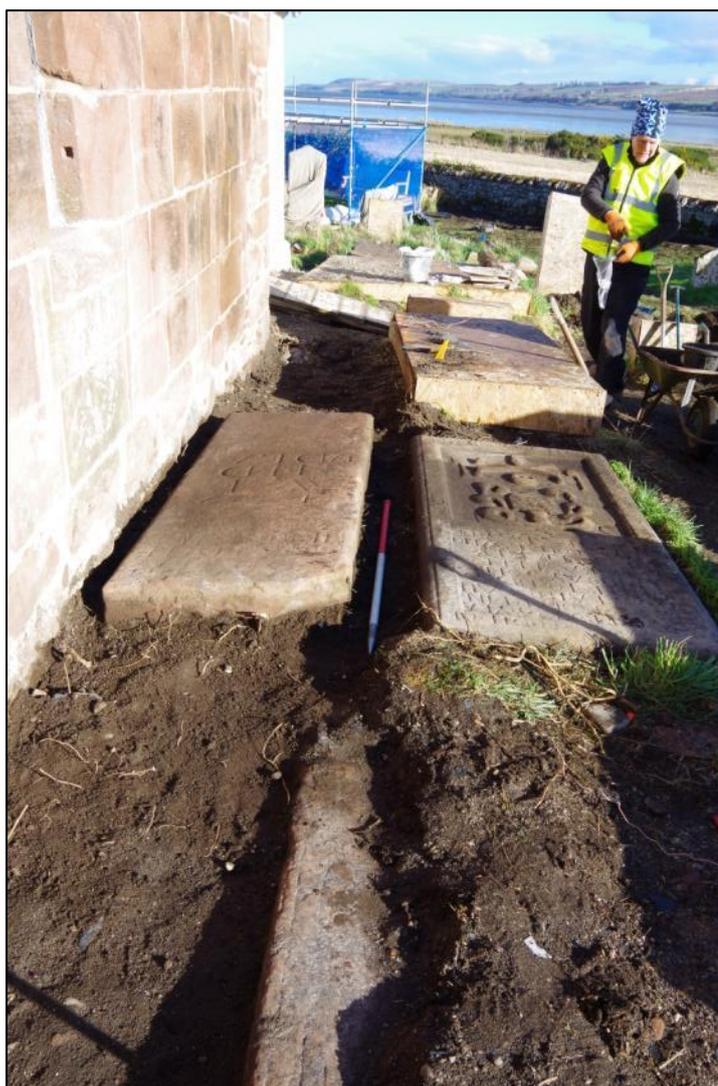
Plate 12: Trench 6 with monuments (Stone 15 in foreground)

Stone 15 = Stone partially uncovered during turf removal, only 200mm width revealed and 1.6m in length. A simple liner border has been carved around the edge of the stone but no further inscription revealed. The channel ditch ran along north side of the monument.

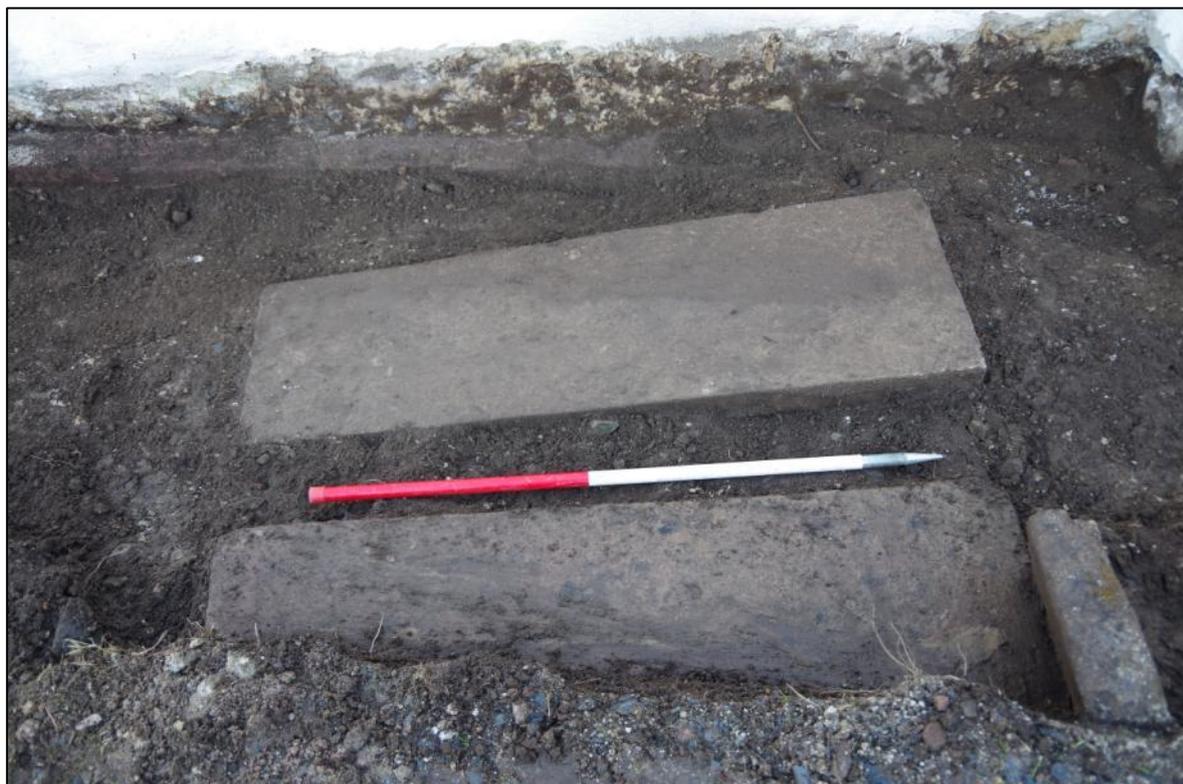
Plate 13: Stones 16 and 17 north of the chancel in Trench 7 (1m scale)

Stone 16 = This short slab is oriented east-west respecting the line of the Kirk, but slopes downwards slightly to the north east. The highest part of the slab (the south west corner) was around 40mm below the surface but the lowest corner (the north east) is around 200mm below surface level. The stone was around 200-300mm away from the north wall of the chancel. It is 1.45m in length by 0.5m wide at the west end and 0.4m at the eastern end. The slab has sharp corners showing little sign of damage or degradation but no apparent inscriptions or markings.

Stone 17 = To the immediate north of Stone 16 lies this stone, partially uncovered by the trench and approximately 200mm below the surface. It is oriented east-west and slopes down to the north. It is 1.45m in length but the full width was not established, a maximum of 0.5m was revealed. This stone also has sharp corners and edges with no damage, but no inscription apparent. A small headstone is present against its western edge and leaning over the stone, standing 200mm taller than the slab, 180mm of its width was revealed and it was around 50mm thick. This also appeared to bear no inscription.

The deeper drainage channel was excavated between these slabs and the ground around them sloped to ensure that water could be carried away from the slabs and the Kirk.

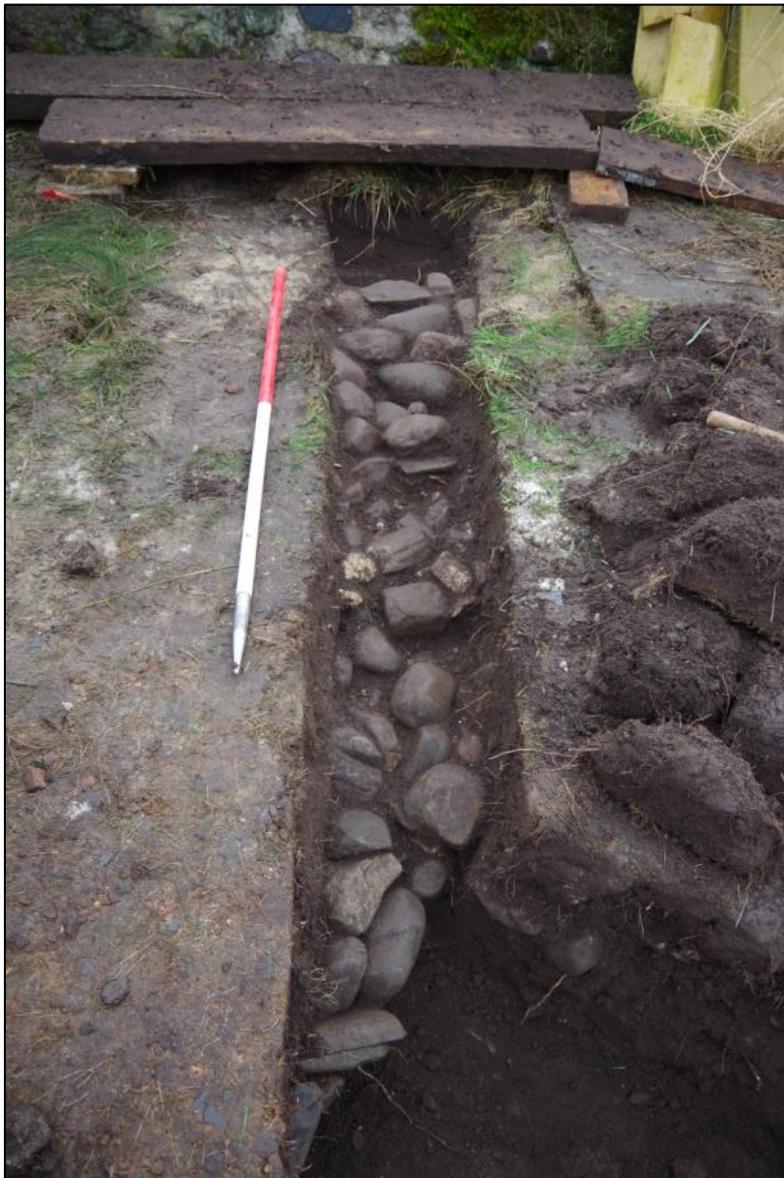
Plate 14: Tumble of stones in Trench 8 (1m scale)

053 = large tumbled stones (mostly 10-20cm) with some patches of mortar, located near (but not up against) the kirkyard wall extending 1.5m, slopes downwards so southern part is close to the surface but towards the north the stones are 250mm below the surface. Surrounded by topsoil (052). This appears to represent tumble from a previous phase of wall, but it abruptly stops around 0.5m away from the present wall. This suggests that it may have been cleared when the wall was constructed.

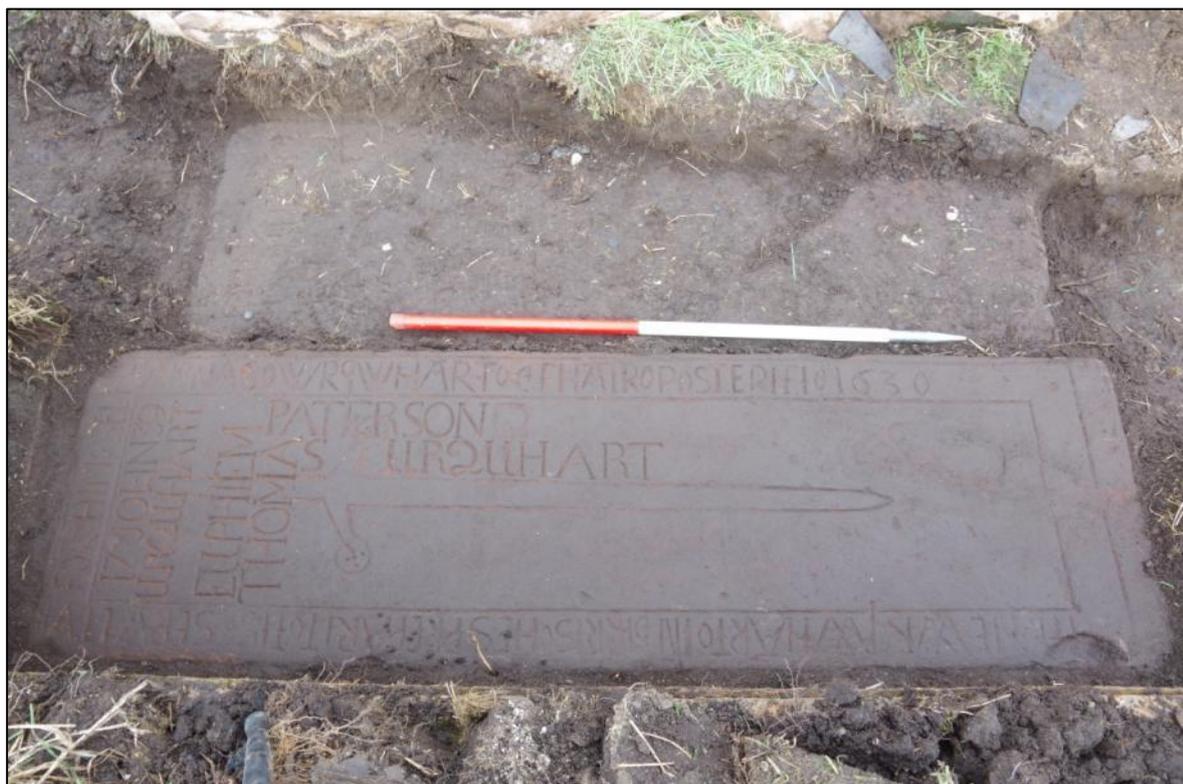
Plate 15: Stone 20 (foreground) with Stone 19 before cleaning, Trench 9 (1m scale)

Stone 19 = Stone slab 1.8m long not fully exposed but 0.65m width revealed. Inscribed with a name ‘John Urquhart’ with some suggestions of decorative carving including boxes and a possible hourglass. There is a deep circular hole approximately 40mm wide and 30-40mm deep just below the carved name. The stone surface is irregular and damaged in many places.

Stone 20 = A slab immediately to the south of Stone 19, 2.1m long and just over 0.6m wide. It is inscribed with an outline of a claymore-like sword in the centre with a lettered border around the edge of the stone reading “?NE WRQWHART ◊ INS?RIS ◊ HES PREPARIT ◊ TIS ◊ SEPWLTUR FOR ◊ HIM ◊ SELF ◊ ANNAS ◊ WRQWHART ◊ OF HAIR ◊ POSTERITI ◊ 1630”. Within the border and overlying the sword carving is also the inscription “1739 JOHN URQUHART, EUPHIEM PATERSON, THOMAS URQUHART”.

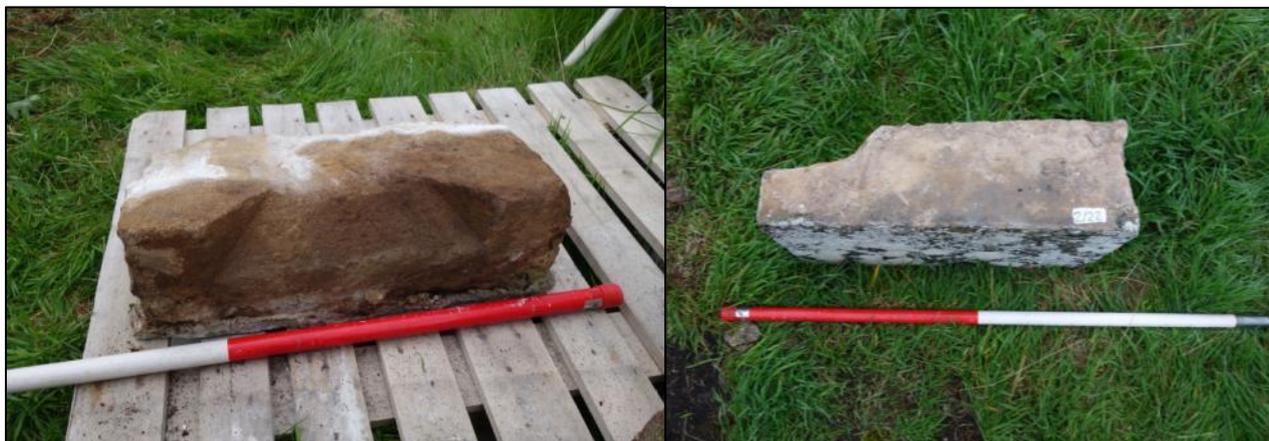
Plate 16: Worked stones from Lady Ardoch Mausoleum (1m scales)

Site visits were regularly undertaken during deconstruction of the **Lady Ardoch mausoleum** in August and September 2016. Stones were numbered and their positions recorded by the stonemason team at Laing Traditional Masonry in order to facilitate reconstruction. The site visits were conducted in order to monitor disturbance to the monument, ensuring that the central material was preserved in situ if possible and checking stones for signs of re-use. All the capping stone slabs around the top of the monument were checked for previous inscriptions or decoration, but none was found. However, two of the stone blocks were found to have evidence of previous working for architectural use rather than monumental (see Plate 16). The shaped surfaces were placed facing the inside of the monument, and whereas the other blocks were of pink sandstone these two pieces are yellow, suggesting that they have been found and utilised rather than imported specifically for use. They may be residual stones from previous phases of the kirk.

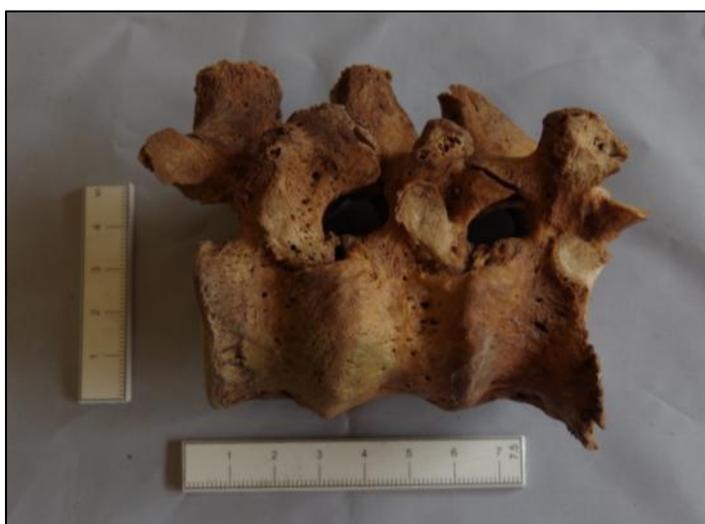
Plate 17: Ossified vertebrae (**005** number 26) (7.5cm & 4.5cm scales)

Many of the human remains set aside for analysis had no notable pathologies or trauma. However, one commonly noted ailment was osteoarthritis, present as bony extrusions on many of the bones, and ankylosis, present in two instances - **005** number 26, and **039** number 4 – with the former being most extreme (see Plate 17). In this instance it indicates prolonged activity causing strain to the lower back. The vertebrae have fused along one side in this instance, which would limit movement and may have been very painful as the discs collapsed. The prevalence of arthritis, still common today, suggests frequent physical activity or advanced age.

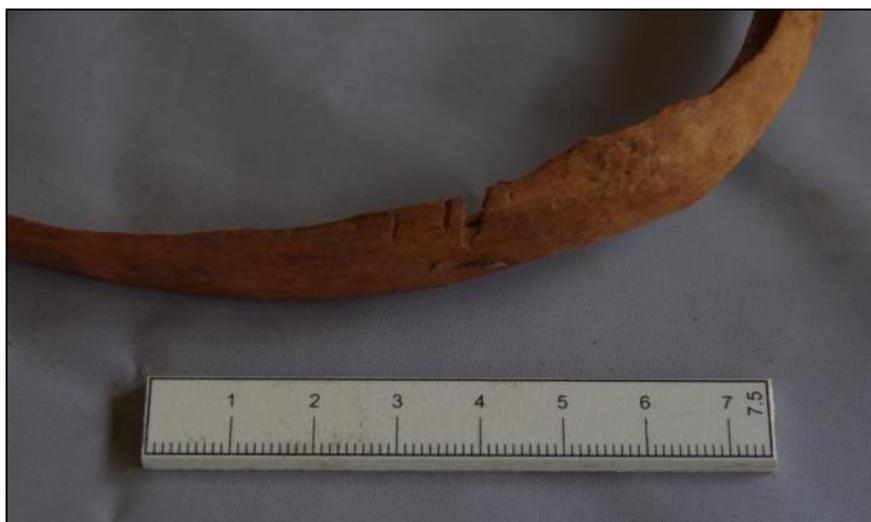
Plate 18: Rib with cuts, 005 number 27

Two ribs present signs of trauma (**003** number 3, and **005** number 27); both have cut marks which are indicative of a violent action – maybe an assault. There is no sign of healing in **005** number 27, and it is possible that this was a cause of death (see Plate 18).
